# Western Railway Preservation Society

*E-News Issue - 3  
April 2010*

## *The Electronic Newsletter of the WRPS*

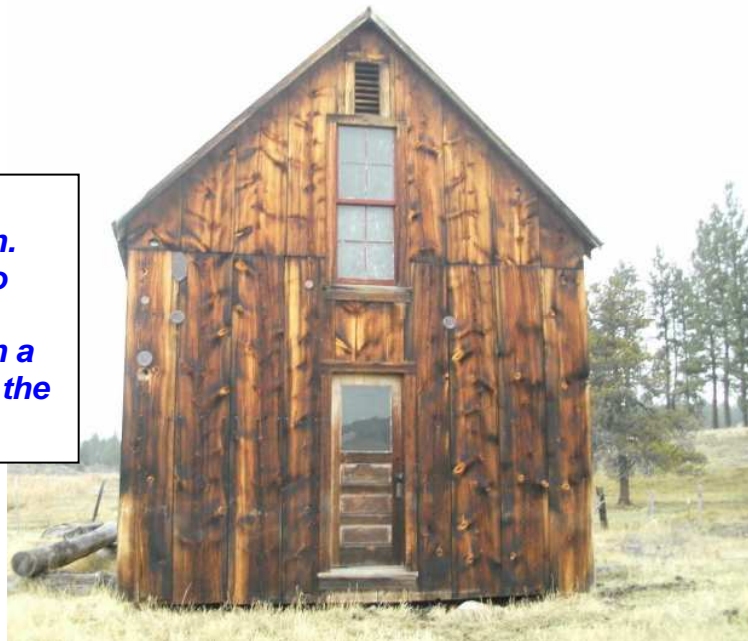
***The old Bunkhouse is in remarkably good condition. The current owner plans to place the bunkhouse in a different location and open a museum in the building in the near future.***

The Bunkhouse is in remarkable condition and while similar to the bunkhouse at Thompson siding, there are several differences, primarily in window and door placement and different siding. The buildings share the same dimensions and construction style.

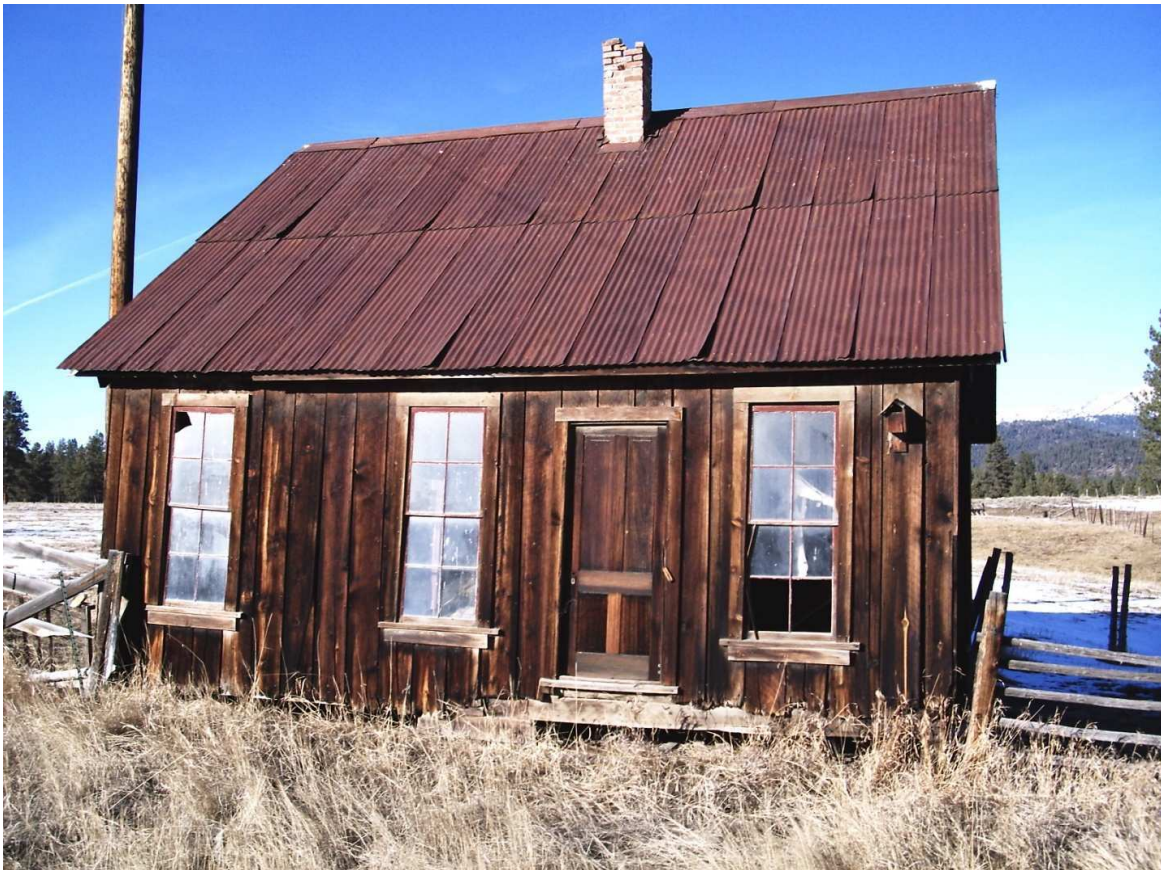
*Here is the McEwen section house as it looks today. Note the similar construction and matching windows with red trim found on this bunkhouse as well as the Thompson depot and bunkhouse seen in part 1 of this story.*

The Section house currently sits across the highway from the Hawley ranch in a unused but stable condition.

Unfortunately the interior of the section house is exposed to the elements and is in poor condition.

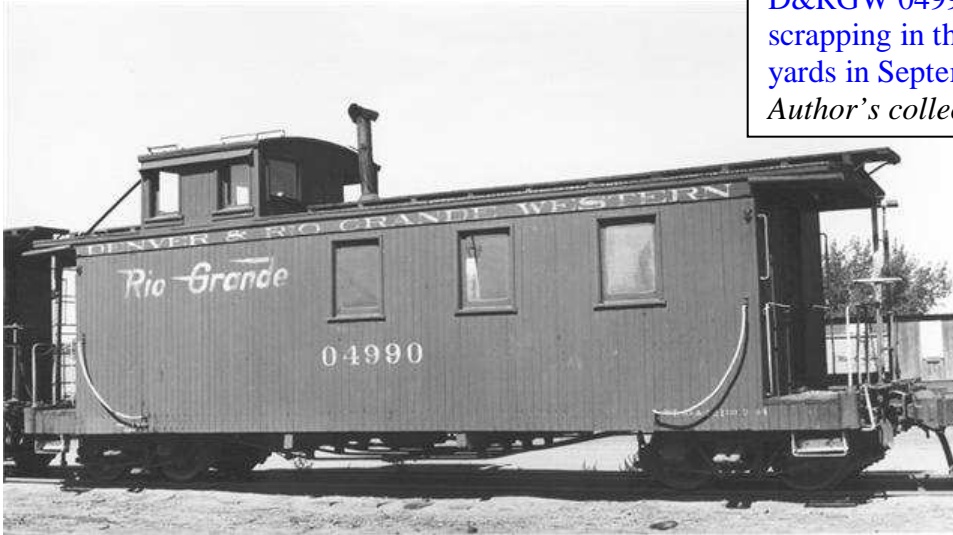
D&RGW 04990, awaiting scrapping in the Alamosa yards in September of 1950.  
*Author's collection*

Caboose 04990's story begins in 1896 when it was built by the Ohio Falls Car Manufacturing Company of Indiana as part of an order for 400 narrow gauge boxcars by the Denver & Rio Grande railroad. Boxcar 4990 served the D&RG for a little over 2 decades before encountering its first major change. In 1919 the Rio Grande's Alamosa car shop converted 4990 into caboose 04990. The conversion resulted in 04990 looking like a standard Rio Grande long caboose, while retaining many of its 4000 series boxcar features, including an overall length of 30' and the low ceiling height of the boxcar's peaked roof.

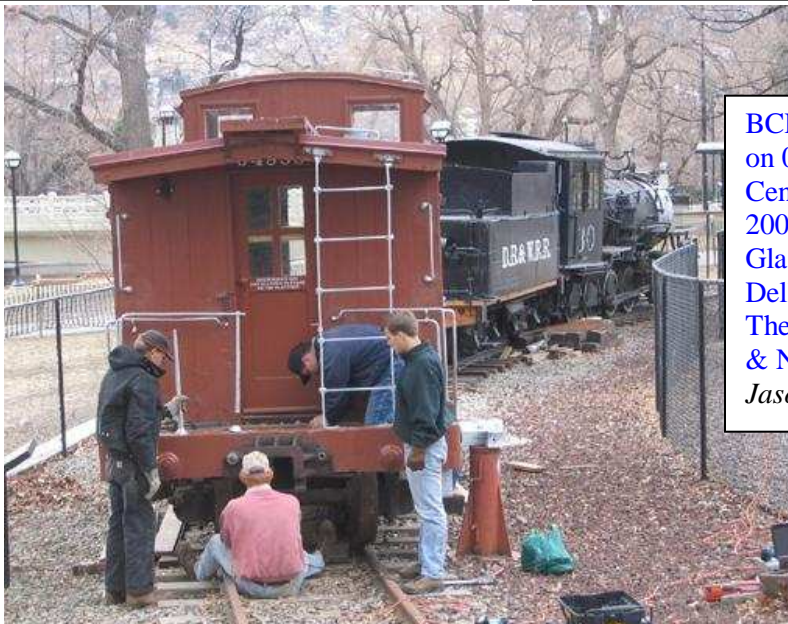
BCRHS volunteers at work on 04990 in Boulder's Central Park on January 25, 2004. (L to R) Adam Glazier, Todd Hackett, Brian Dellaplaine, Chris Weaver. The locomotive is Colorado & Northwestern #30. Jason Midyette photo.

In 1998, the newly formed Boulder County Railway Historical Society (BCRHS) undertook the restoration of 04990. Over the next few years, BCRHS volunteers were able to accomplish a lot of work and 04990's condition was vastly improved. Funding for the restoration came from a combination of private donations and small grants from Colorado's State Historical Fund. A parts swap with the Friends of the Cumbres & Toltec Scenic Railroad saw some of RGS

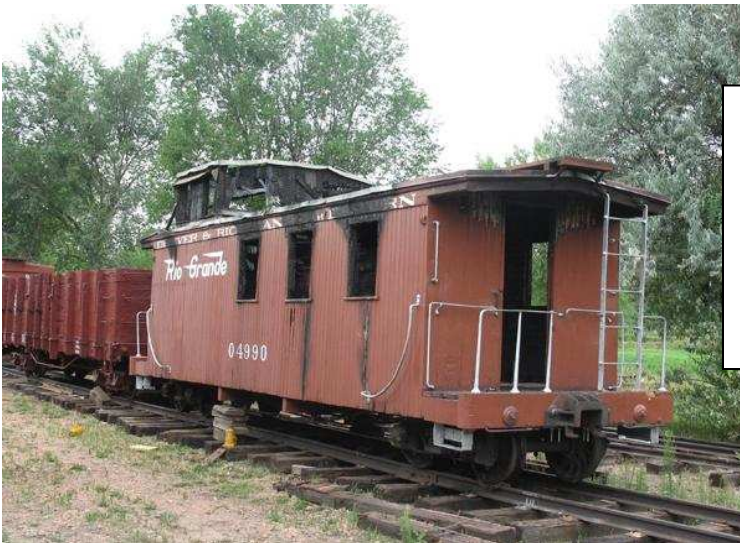
**[After the fire D&RGW 04990 was a gutted ruin upon its arrival at the BCRHS's Valmont display site on July 27, 2007.](#)**

Seconds later, the old caboose that we had spent so many years working on erupted into flames and all our hard work was now going up in smoke. For the members of the Boulder County Railway Historical Society, it was not a good day.

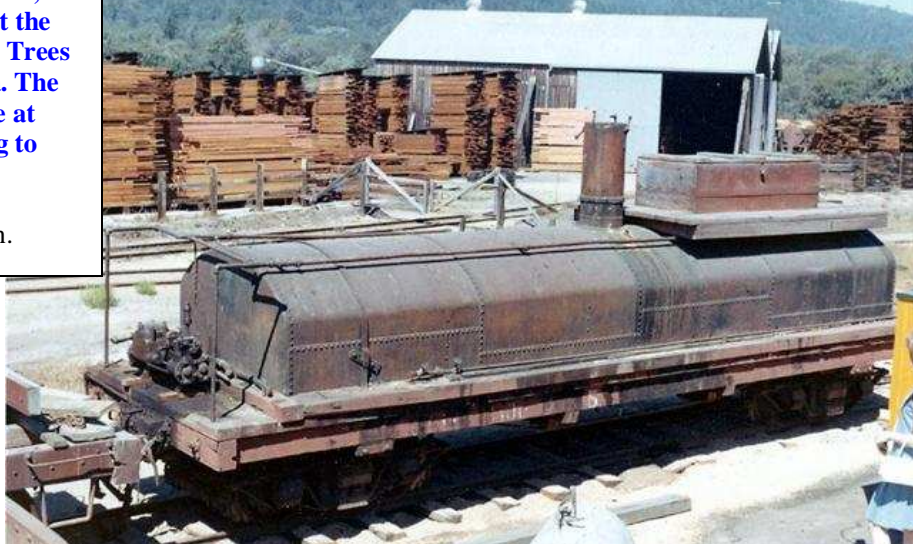
Taken in the late 1960's, this shows Tank #5 at the Roaring Camp & Big Trees railway in California. The car was still complete at this time, but starting to deteriorate.

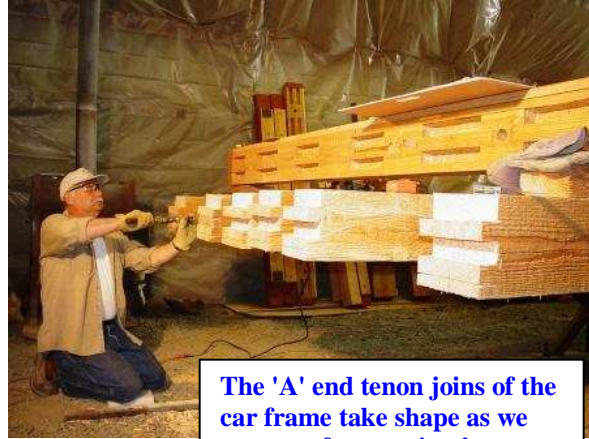
**The 'A' end tenon joins of the car frame take shape as we see one of our society's directors, Arnie Lipshetz chiseling out the last piece.**

The West Side Lumber Company car shops used the tried-and-true double mortise and tenon joints for holding the main beams and end beams together. So, each long beam required careful measuring and cutting to match the original tenon joints. Each set of tenons also received a coat of paint like the originals, an early method of preserving the wood to try to avoid rot at these critical joints.

When the 'A' end tenons were finished and we tried to fit the new end beam on the 'A' end of the frame, we soon discovered two things: 1 - we were not

building fine furniture and our clearances were way too tight and 2 - the worst that the long eight-inch square beams had twisted as they had dried. The new end beam had the carefully cut mortises opened up by an eighth of an inch, and by shimming the beams we were able to get our first end beam into place.

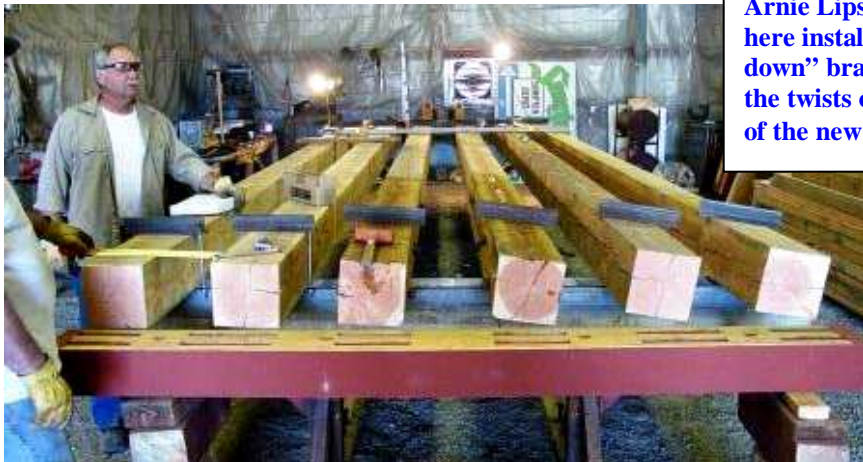
**Arnie Lipshetz is seen once again here installing the steel "hold down" brackets that will remove the twists out of the main beams of the new car frame.**

The twist in the beams was an unexpected problem. When originally built, the car's frame was probably put together in a week or two, and we were working over a period of months to get to the same place. After some brainstorming, we came up with a plan. Angle iron and long bolts would be used to tie the beams down to the flat tops of the steel sawhorses, hopefully reversing the twisting so the second end beam could be slid over the 'B' end tenons and into place.

The following work weekend we drilled holes in the sawhorses, and added the new hold downs and bolts. Much to our delight and relief, they worked!

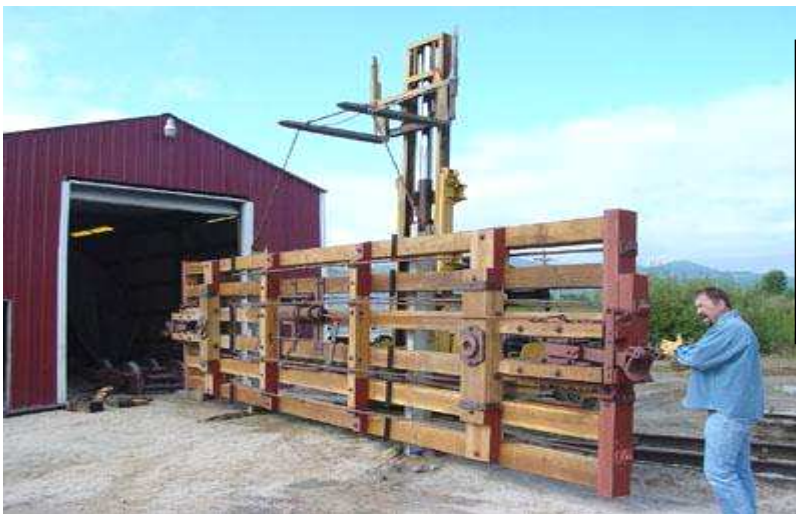
**Jerry Huck helps to guide the forklift operator as the newly completed tank car frame is flipped right side up and placed on its trucks. Building the frame up side down allowed much easier installations of the car’s hardware.**

In September 2009, after a year’s worth of work weekends, the frame was ready to be flipped over and placed on the rebuilt trucks. The flip went well, using the SVRR fork lift and lots of muscle. The trucks were rolled into place, and the frame went out for several test runs to check clearances, coupler height, and to seat the rebabbitted truck bearings. It went surprisingly well - a real tribute to all of the time and effort given by great bunch of volunteers.

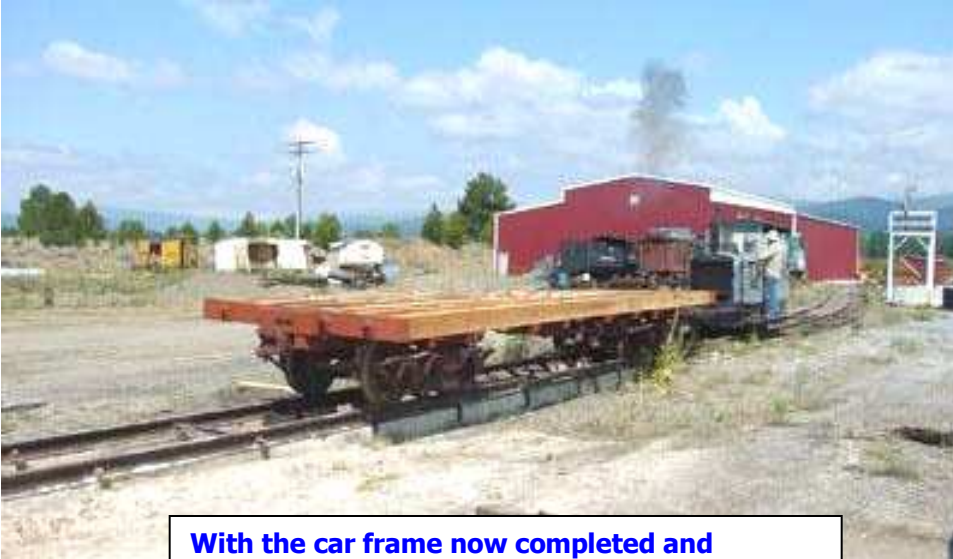
**With the car frame now completed and installed on its trucks, the new car is off for some test runs with help from the Sumpter Valley Railway's 10-ton switch engine.**

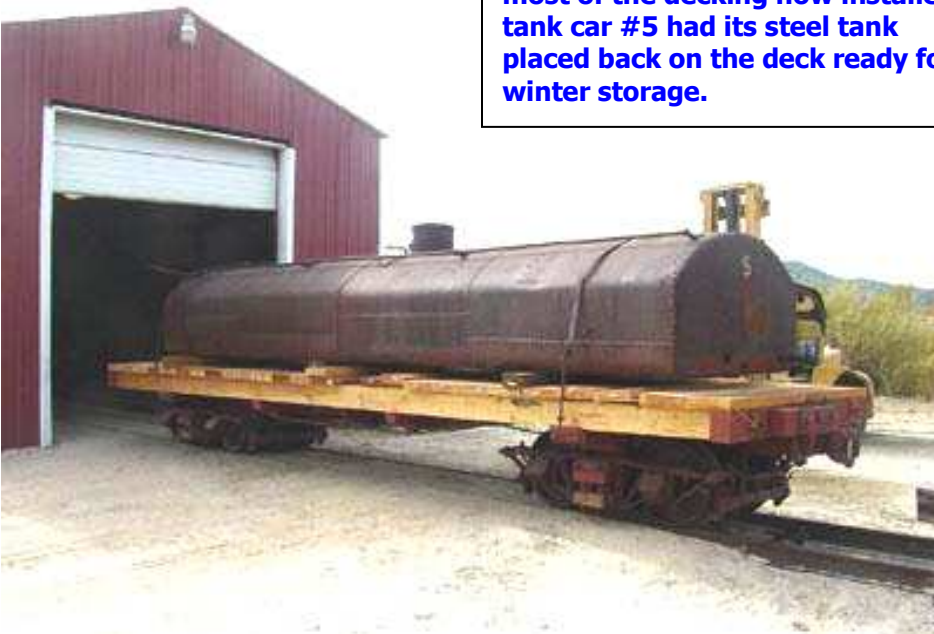
**With the test runs completed and most of the decking now installed, tank car #5 had its steel tank placed back on the deck ready for winter storage.**

October 2009 saw the start of the new flat car decking, and the tank was placed back on the frame and rolled under cover for the winter – the first time Tank #5 had been this complete in nine years.

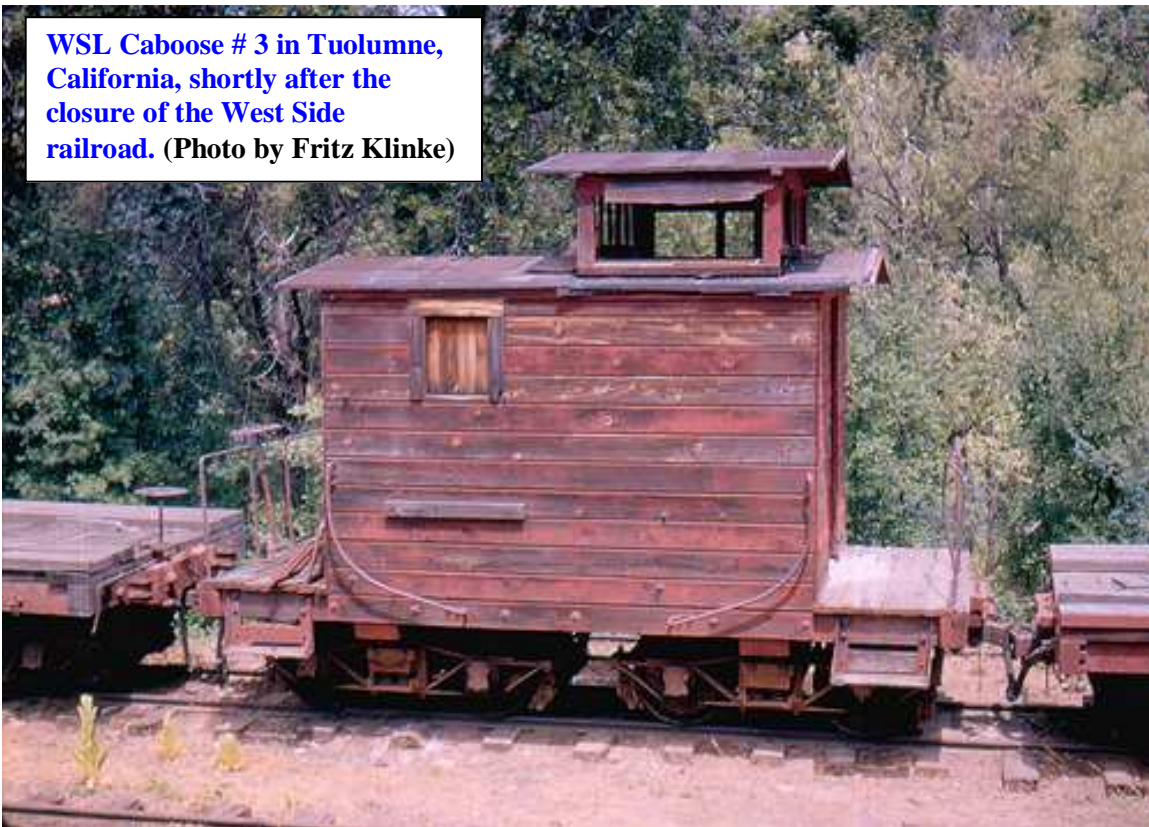
**WSL Caboose # 3 in Tuolumne, California, shortly after the closure of the West Side railroad. (Photo by Fritz Klinke)**

Mike Roberts, who heads up the WSL tank car #5 project, volunteered to accompany me on a trip to inspect the caboose. Mike quickly pointed out that the caboose was actually West Side caboose first #3 which later served the WSL as a sand facility at their camp 45. The caboose had then served West Side successor the West Side & Cherry Valley tourist railroad until that operations closure in the mid 1980's.

The trucks show light rust on the exterior but the bearing surfaces and boxes are clean and well lubricated, the caboose does not have air brakes but does have a brake pipe and a conductors valve to apply brakes from the caboose.

Now the bad news, although the car's metal hardware is in good condition the same can't be said of the wooden components. The sills and end beams are badly rotted, the car framing is questionable and the cupola is sagging from having the supports removed to make room for the benches.

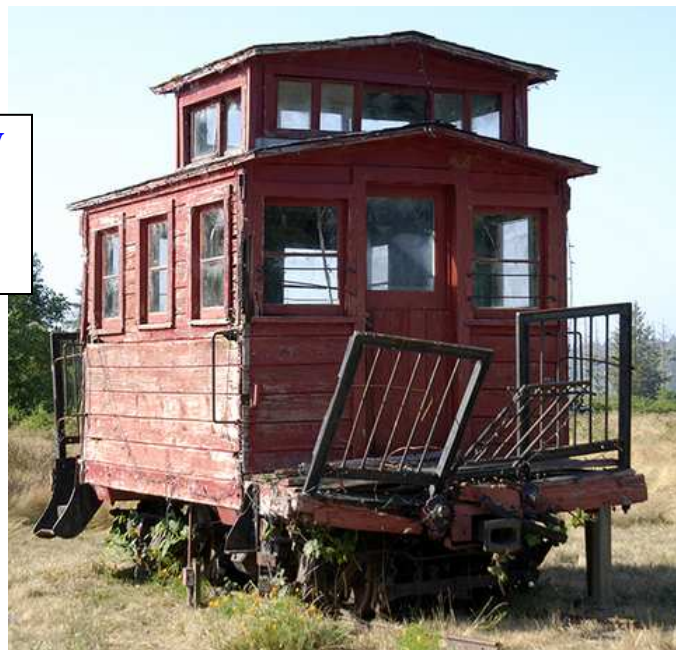
**WSL #3 at the Stone Lagoon RV Park and Campground near Trinidad, California.  
(Photo by Hart Corbett)**

The caboose trucks have good wheels and brake shoes. All the draft gear for the link and pin couplers are still intact as is most of the brake rigging.

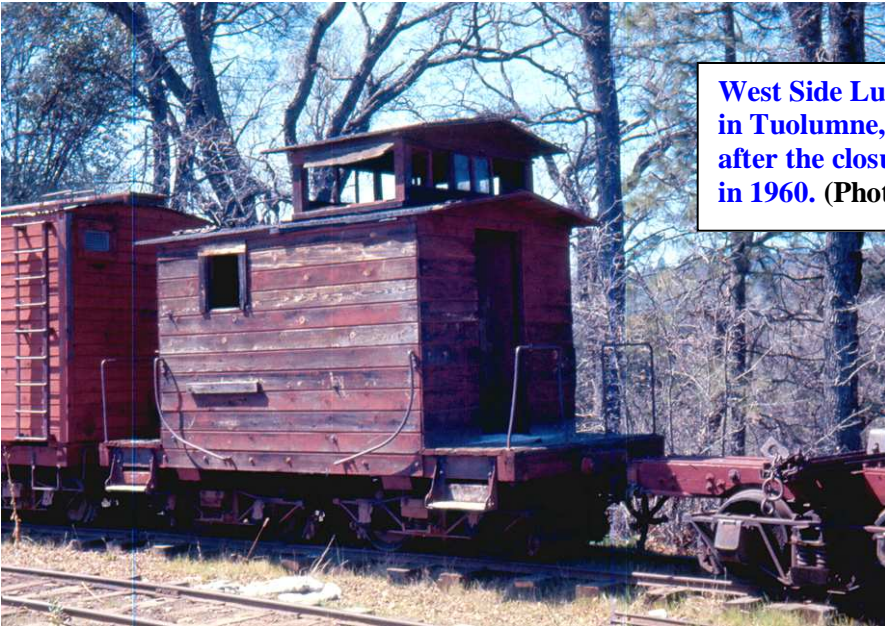
**West Side Lumber Caboose # 3 in Tuolumne, California, shortly after the closure of the railroad in 1960. (Photo by Fritz Klinke)**
